## **RAILROAD ACCIDENT REPORT**

**HEAD-ON COLLISION BETWEEN  
IOWA INTERSTATE RAILROAD EXTRA 470 WEST  
AND EXTRA 406 EAST WITH RELEASE OF  
HAZARDOUS MATERIALS  
NEAR ALTOONA, IOWA  
JULY 30, 1988**

**NTSB/RAR-89/04**

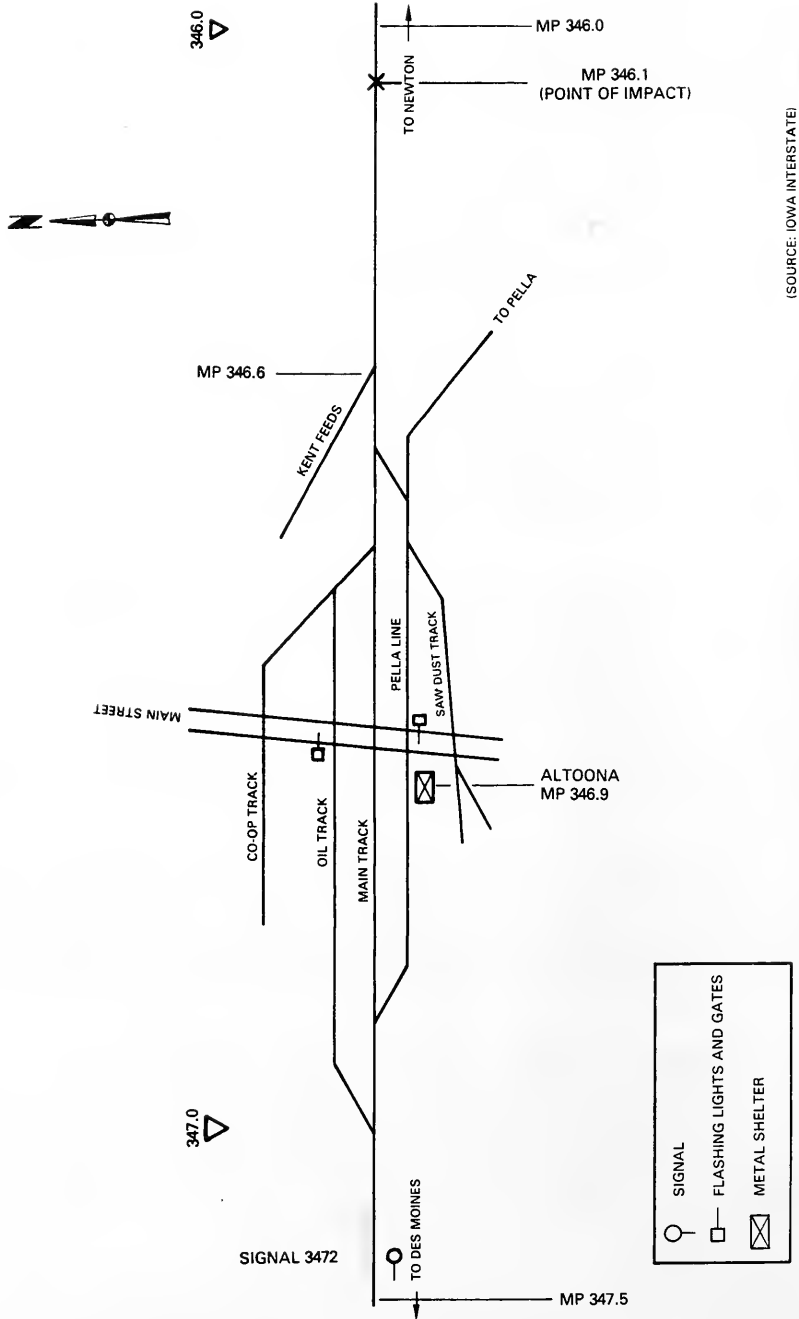
Figure 2.--Layout of Altoona Yard Track.

Safety Board investigators observed that signal No. 3472, located approximately 0.3 mile west of the Altoona station (see figure 2), had not been removed, covered, or turned away from the track.

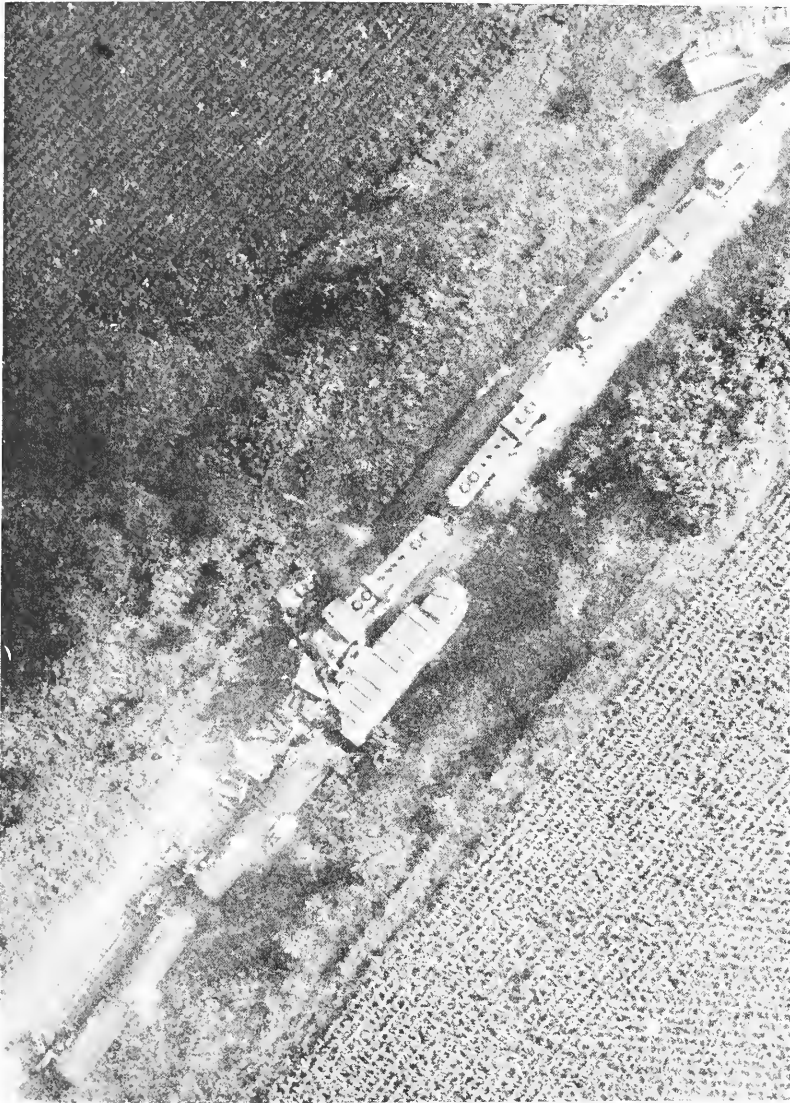
engineer observed Extra 470 West approaching. He estimated the two trains were about 300 feet apart and that his train was traveling between 15 and 20 mph at the time. He stated that "I thought I put the train in emergency. I shut the throttle down, put the train in emergency...." He stated that he left the engine through the cab door on the left (north) side of the cab of the engine, crossing over in front of the conductor who was sitting on that side of the cab doing paper work. He stated that as he was leaving the cab, he yelled at the conductor, "There's a train. Let's jump." The conductor stated that he did not hear the engineer say anything to him and that when he saw Extra 470 West coming around the curve, he positioned himself on the cab floor, braced his feet, and wrapped his arms around the control stand. A few seconds later, Extra 406 East and Extra 470 West collided head on within yard limit territory near MP 346.1. (See figure 3.)

Figure 3.--Extra 406 East (left) and Extra 470 West (right).

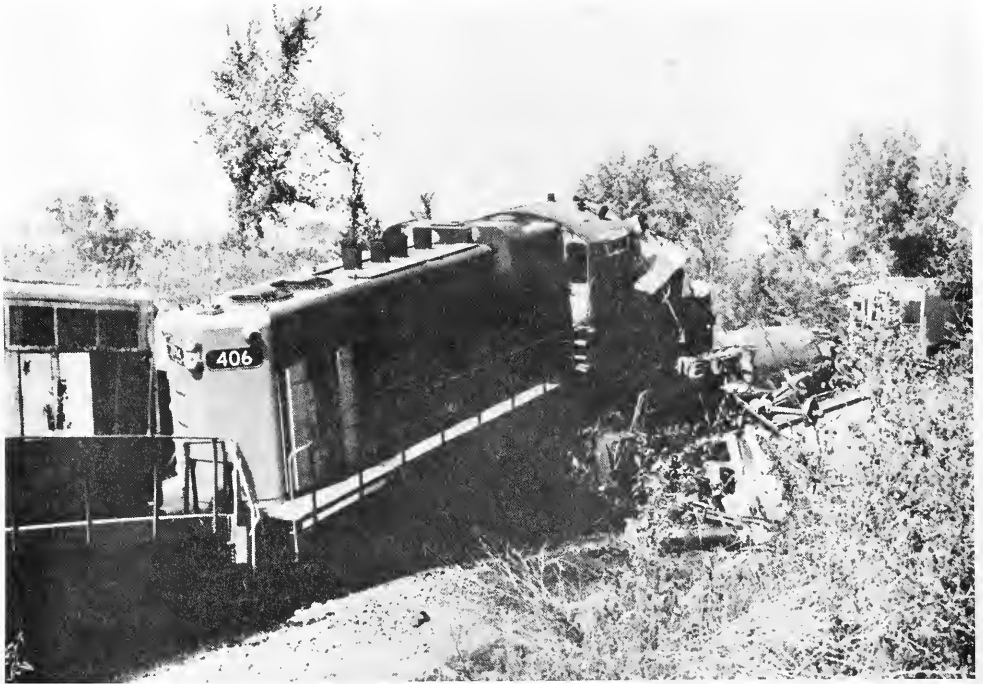
Figure 4.--Unit 406 Overriding Unit of 470 West.

Extra 406 East.--The lead unit of Extra 406 East received major crush damage to the front with sheet metal displacement that extended 2.5 feet to the rear. The interior of the cab of this unit was destroyed by the post-accident fire. The remaining units received light to moderate damage. The trailing unit received damage when it was struck and overridden by the first car of the consist. Three of the 11 cars that derailed were destroyed.

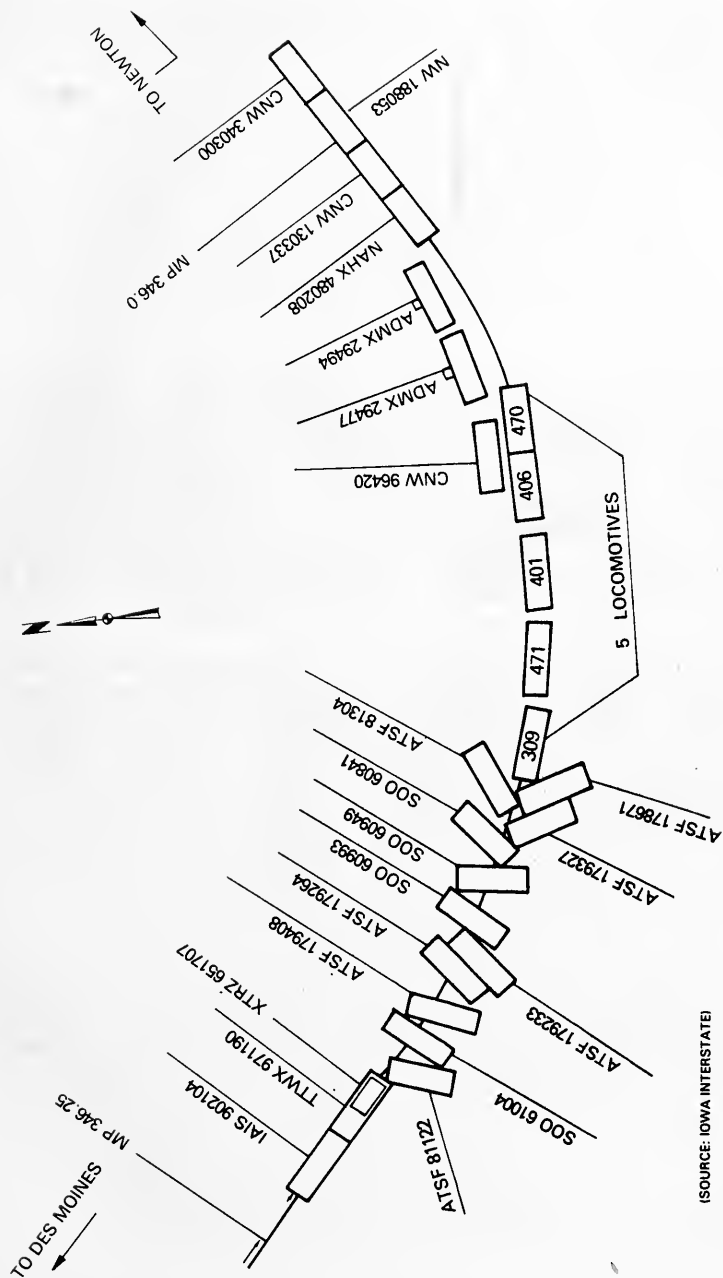
Figure 5.--Sketch of Derailment.

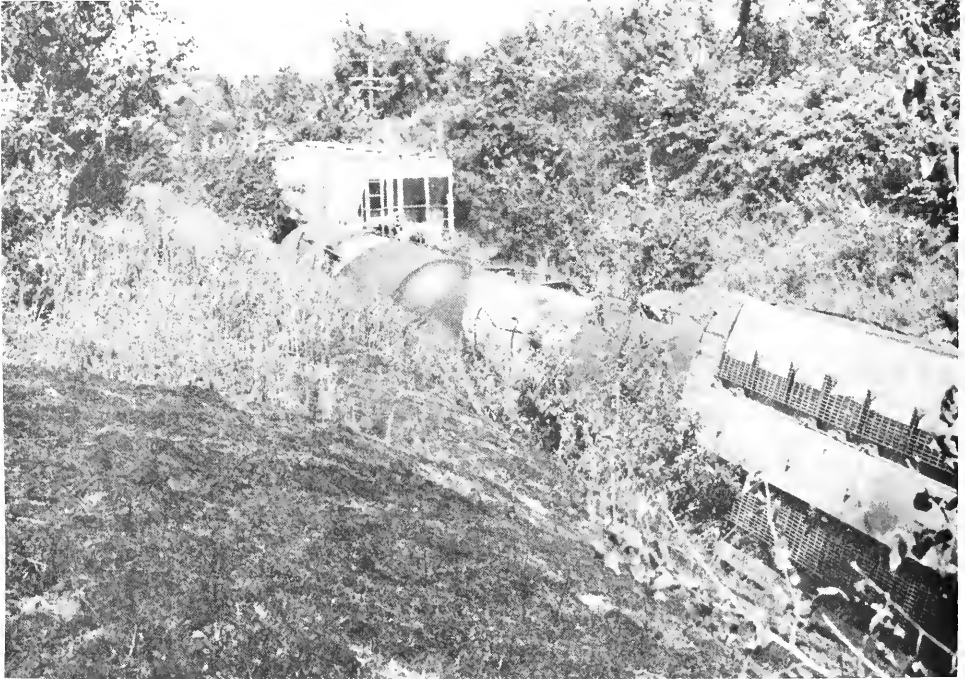
The postaccident visual inspection of the two tank cars on the afternoon of August 2 revealed a dent in the tank shell head at the B-end, or leading end, of ADMX 29477, the lead tank car (second car from the head end) in the train. When facing the B-end, there was a crease on the left side of the tank shell just forward of the first circumferential weld seam in the side shell. The tank shell was scorched and burned around the manway and the pressure relief valve toward the A-end. The scorched and burned area extended about 2/3 the tank length from the manway toward the A-end and on the side of the tank that faced up on the overturned tank. The paint around the manway had been burned away, or was blistered. There was no visible

Figure 7.--Burning at Manway Cover of ADMX 29477 (foreground) and ADMX 29494.

warping, buckling, or other obvious indications of structural damage to the tank shell observed. The bottom outlet valve extension and cap did not have any obvious damage. The manway cover and nozzle were not visibly warped. The area where the gasket contacted the manway cover had some unknown residue that had burned, but had no visible scars or marks.

The A-end of ADMX 29494, which had been the leading end of the car, had no visible damage. A small crease was found in the tank shell on the side that had been on the ground toward the B-end of the tank car. The tank shell was scorched around the manway opening and the pressure relief valve toward the A-end of the car. The scorched area extended around the side of the overturned tank that faced up, but it did not extend toward either end of

the tank. The paint in areas adjacent to the scorching was blistered. The bottom outlet valve extension and cap showed no visible damage. The manway nozzle and lid were not visibly warped or deformed.
